O.R. CEILING CONSTRUCTION: FROM TURF WARS TO TEAMWORK

**Precision Air** *The O.R. AirCare Specialists*

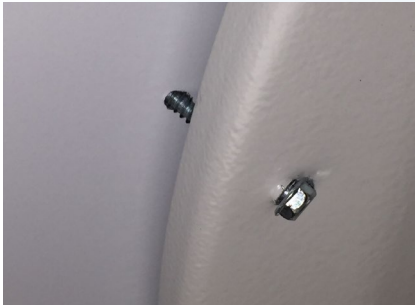
PROBLEM: Ceiling cobbled together with makeshift pieces visible from the OR.

CAUSE: Installers “just making it work.”

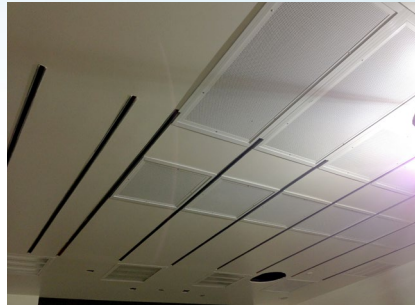
PROBLEM: Expensive, time consuming, and chaotic looking patchwork of components.

CAUSE: Thinking “this is the way we’ve always done it.”

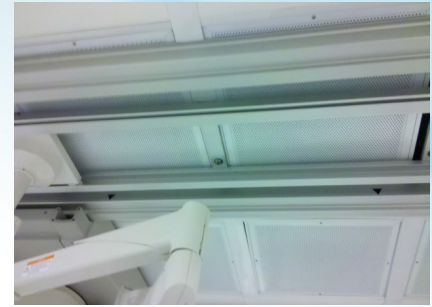
PROBLEM: Medical equipment obscuring diffusers. Filter access requires disassembly of all attached equipment.

CAUSE: Inexperienced mechanical designer placing diffusers over medical equipment.

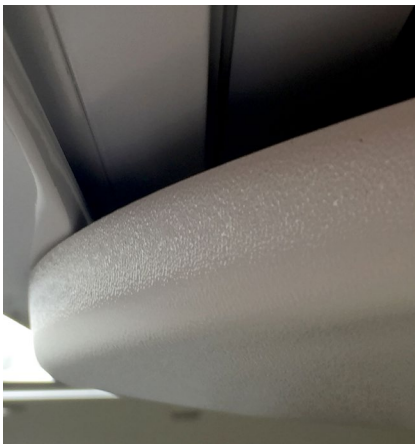
PROBLEM: Difficult to access light and unprofessional appearance.

CAUSE: Lack of coordination between ceiling designer and medical equipment.

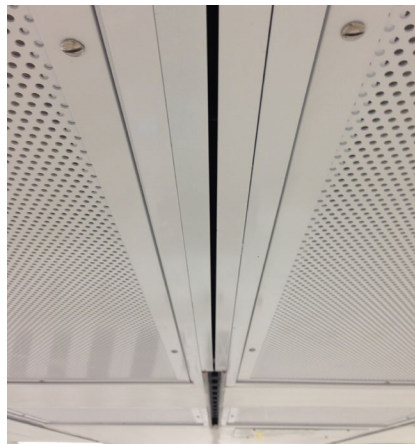
PROBLEM: Gap between framing allowing dirty air into room.

CAUSE: Lack of understanding of structural Unistrut integration and airflow.

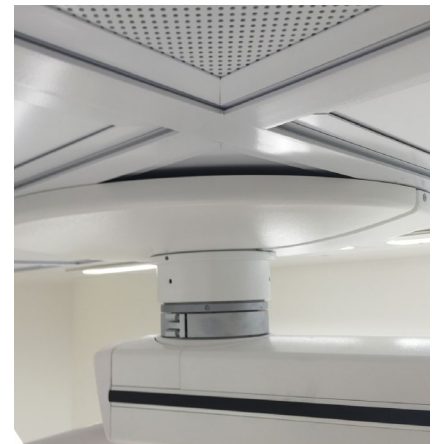
PROBLEM: Boom overlap on framing leaves large gap for contaminants to leak into room from above the ceiling. Unprofessional appearance.

CAUSE: Result of ceiling system not being coordinated with boom details.
